Operation & Maintenance Manual

Model C/CA/CF/CFA 105 & 106-Pressure Reducing Valve with Solenoid Override

PRESSURE REDUCING VALVE with SOLENOID OVERRIDE

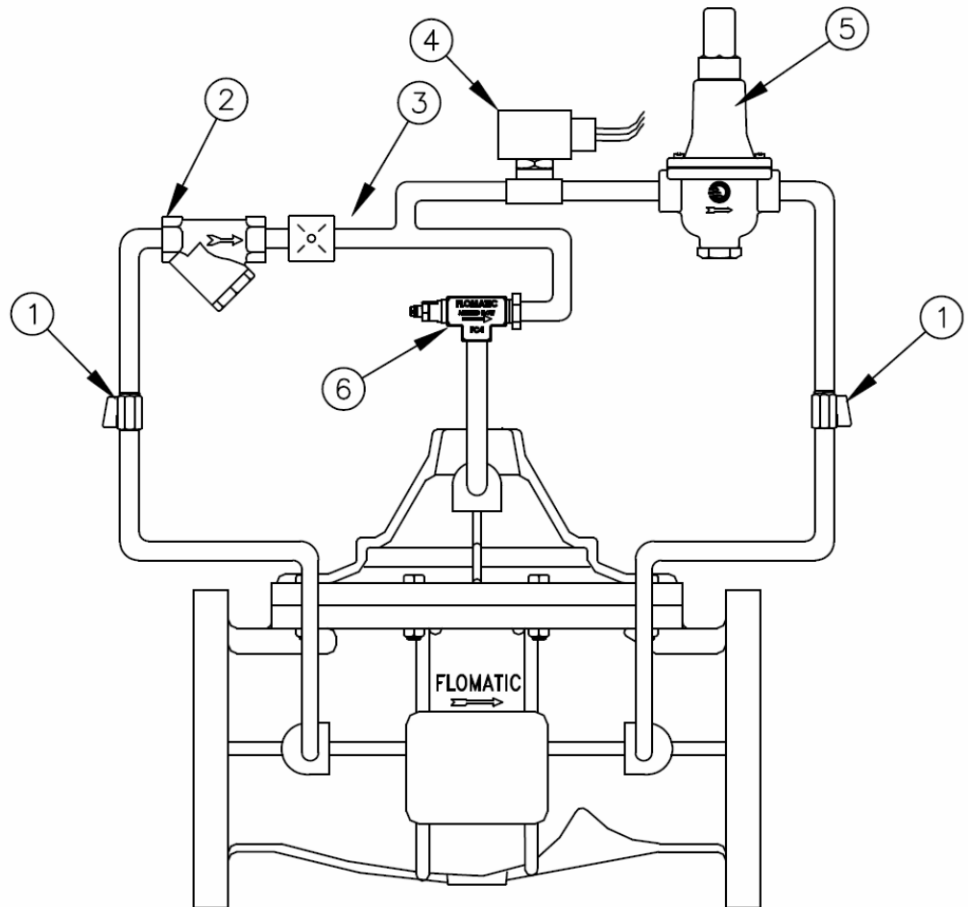
Part List

1. Isolation Valve
2. Y-Strainer
3. Orifice (restriction fitting)
4. Solenoid Valve
5. Pilot (Model PRP)
6. Flow Control (FC4)

The Models C/CA/CF/CFA 105 & 106 Pressure Reducing Valve with Solenoid Override controls and maintains a preset, reduced downstream (outlet) pressure by causing the main valve diaphragm assembly to throttle and sustain the desired reduced pressure regardless of variations in demand and upstream (inlet) pressure. The throttled position of the main valve diaphragm assembly is controlled by an adjustable pilot valve operating in conjunction with an orifice (or needle valve).

The PRP senses the downstream (outlet) pressure and reacts immediately to reposition the diaphragm assembly as the outlet pressure tends to increase or decrease with varying flow demand. The PRP diaphragm will automatically sense changes in the flow of the system as it continuously controls the main valve to throttle or to open and maintain the desired, preset reduced outlet pressure.
